# Home Inspection Report

Inspected by:  
Dan Holzer  
Castle Home Inspections, Inc.

Style of building **2 Story**  
Approx. Age **42 yrs**  
Radon Fee: **N/A**

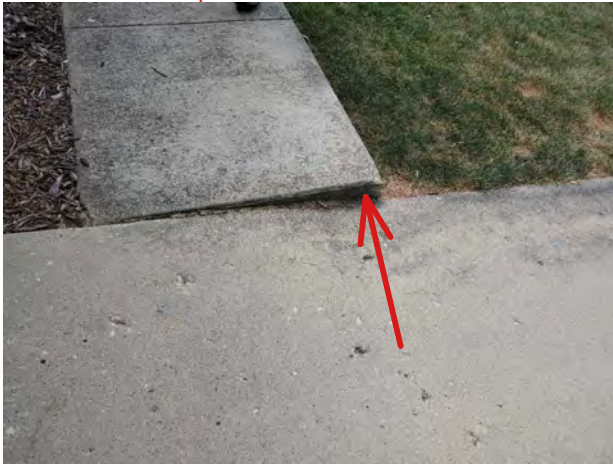
1. ☐ ☐ ☐ ☒ ☐ Trees, Shrubs, Vegetation. Etc. Comments **Tree limbs over hang the roof and should be cut back.**
2. ☒ ☐ ☐ ☐ ☐ Retaining walls
3. ☐ ☒ ☐ ☐ ☐ Fences
4. ☐ ☒ ☐ ☐ ☐ Shed/out building
5. ☐ ☐ ☐ ☒ ☐ Steps, Stoops, Walks Comments **Walk is uneven and a potential trip hazard at front sideway. Recommend repair as needed.**

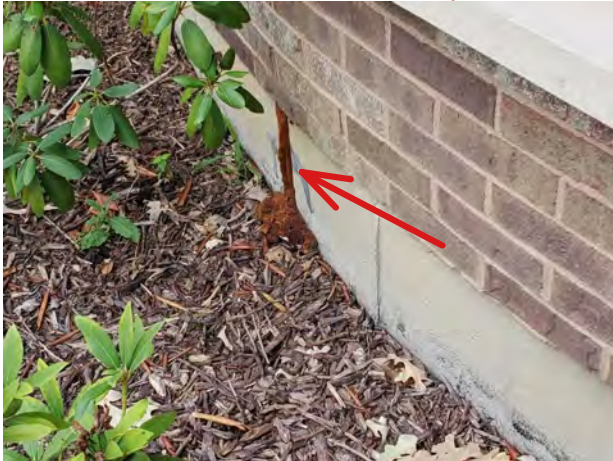
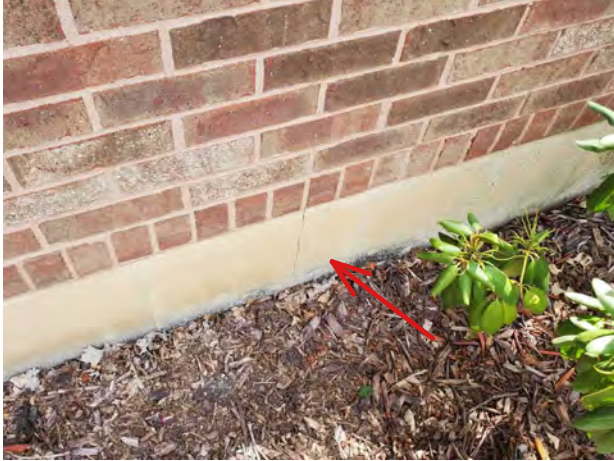
6. ☒ ☐ ☐ ☐ ☐ Grading
7. ☐ ☐ ☐ ☒ ☐ Foundation -Poured Concrete Comments **Cracks noted on foundation at SW wing wall. Crack repair noted at West side. Recommend repairs as needed.**

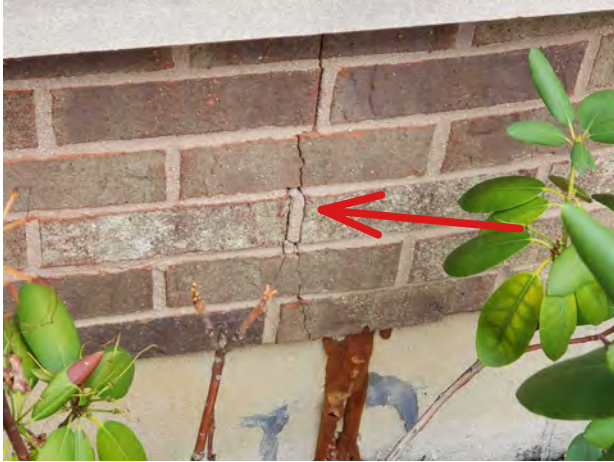
8. ☐☐☐☒☐ Siding Brick and aluminum Comments Cracked, missing or loose mortar noted on bricks at West side. Dents noted on aluminum siding at NE corner near deck. Loose siding noted at upper East bedroom windows. Recommend repairs as needed.

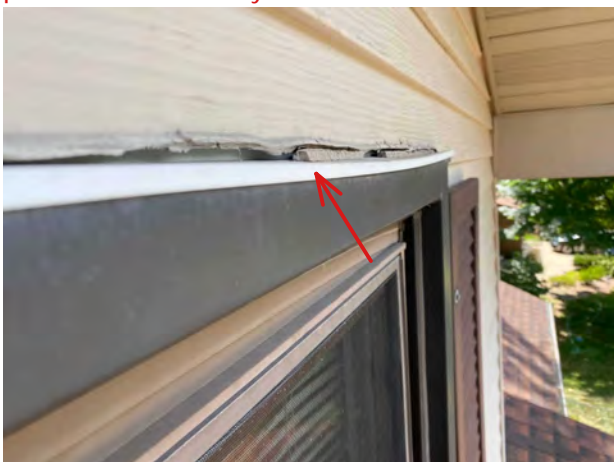
9. ☐☐☐☐☒ Caulking Comments Missing caulking noted at siding to brick transitions and wall penetrations at South side. Failed caulking noted at window and door openings, recommend replacing to prevent water entry.

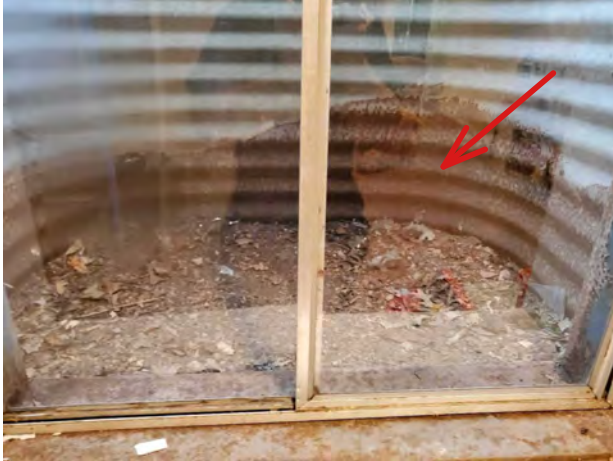
10. ☐☐☐☒☐ Window wells Comments Damaged cover noted at East side. Metal window frame is rusted. Recommend repair as needed and ladder needed at escape window.

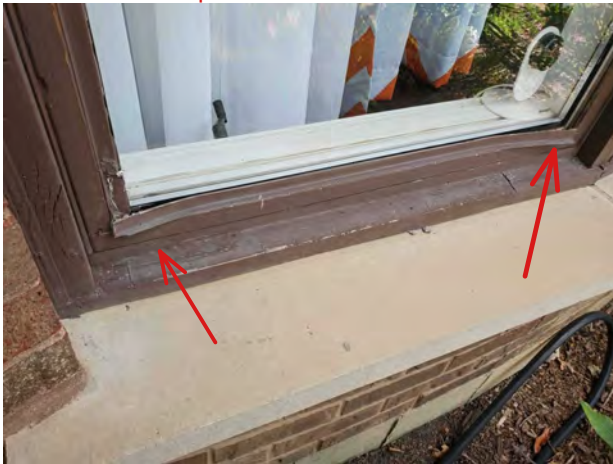
11. ☒☐☐☐☐ Fascia and trim  
12. ☒☐☐☐☐ Eaves/overhangs  
13. ☐☐☐☒☐ Storm/Entry doors Comments Front entry door is not latching. Repair needed for proper function.  
14. ☐☐☐☒☐ Windows/Screens/Storms Comments Plastic glaze pieces around front bay window is damaged. Recommend repair as needed.

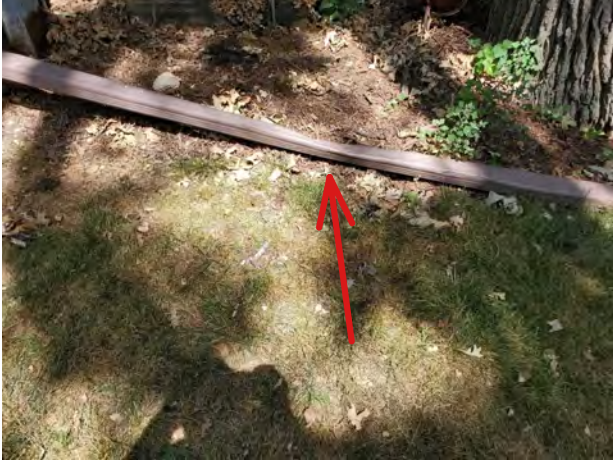
15. ☐☐☐☒☐ Gutters/Downspouts Comments Screens in gutters are dirty. Recommend cleaning as needed. Downspout extensions suggested all around house to help divert water away from foundation and alleviate potential water in basement. Dented downspout extension noted at South side. Recommend repair as needed.

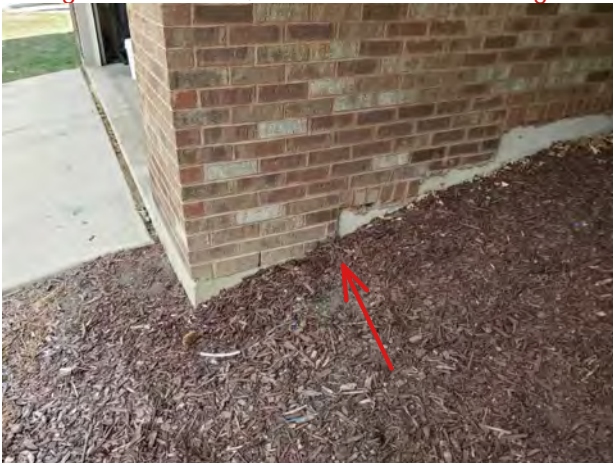
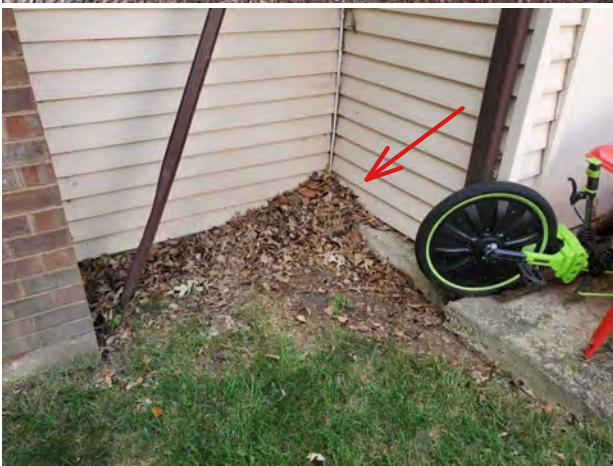
16. ☐☐☐☒☐ Dirt touching wood Comments Dirt or mulch is covering bricks at West side. Dirt or mulch is covering siding at North side, Recommend removing dirt to prevent rot or bug damage.

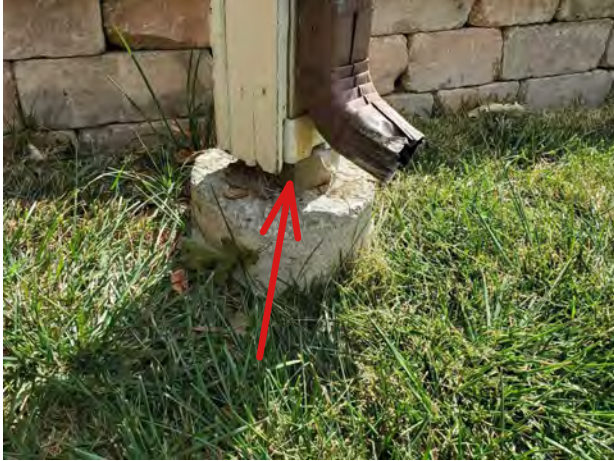
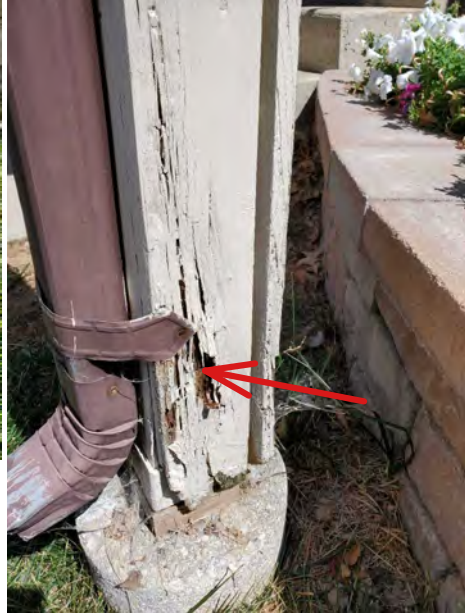
21. ☐☐☐☒☐ Porch/Gazebo Comments Front porch post has rot and is shimmed with 2x4. Recommend having checked and repaired as needed.

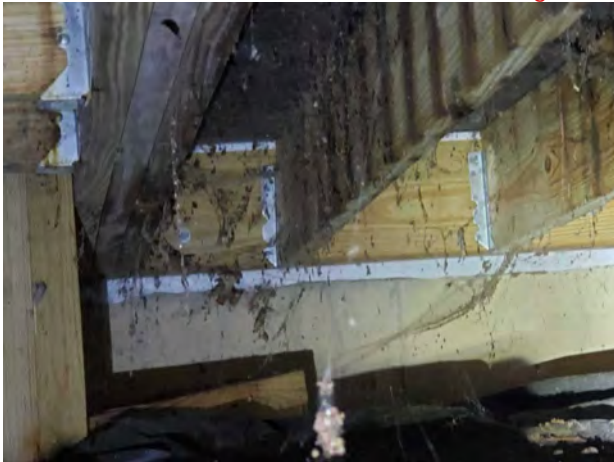
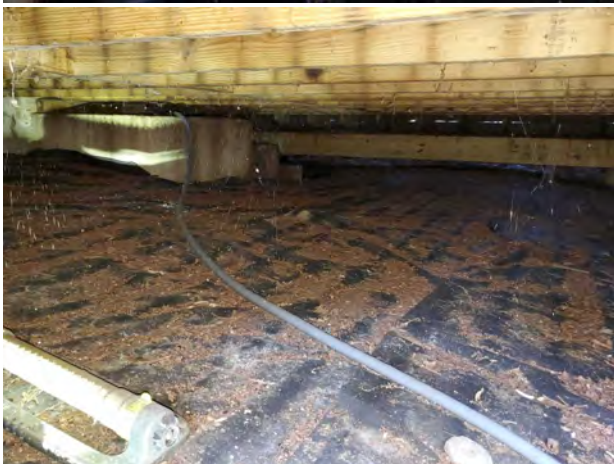
22. ☒☐☐☐☐ Deck Comments Deck built on or close to grade, unable to inspect all of the underside structure.

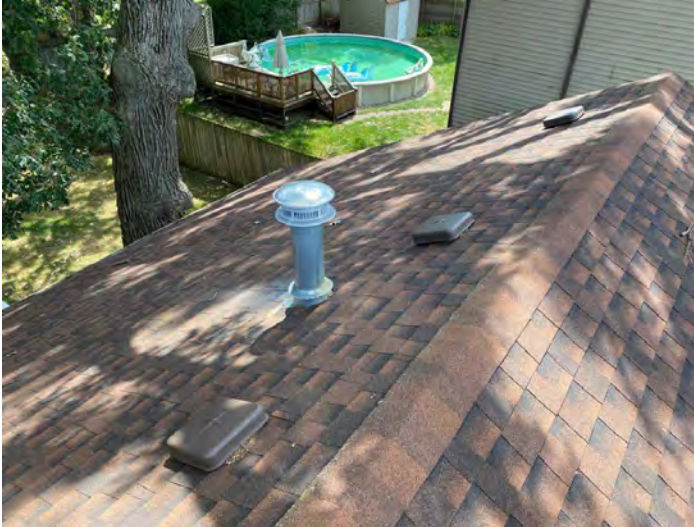
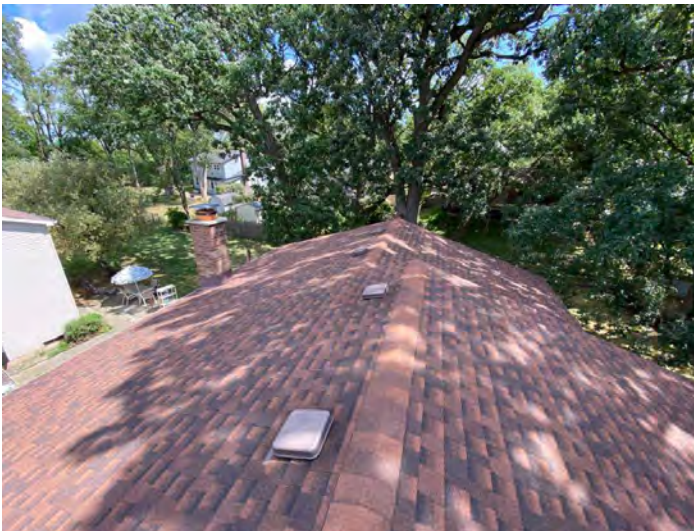
1. Roof Type **Gable**
2. Roofing Material **Fiberglass shingle**
3. Number of layers **1 Layer** Estimated age **5 yrs Per seller**
4. Method of inspection ☐ From eaves ☐ From ground ☒ Walked  
S NPNI F P
5. ☒ ☐ ☐ ☐ ☐ Roof condition

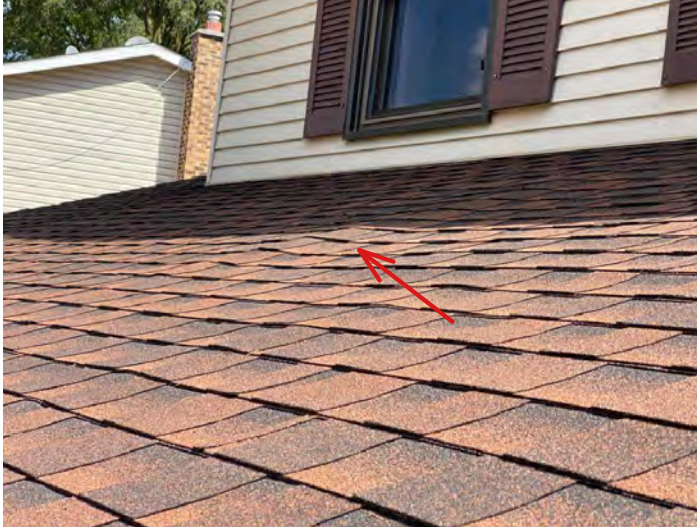
6. ☐☐☐☒☐ Deflection noted Comments **Buckled shingles/sheathing noted on lower garage roof. Recommend repair as needed.**

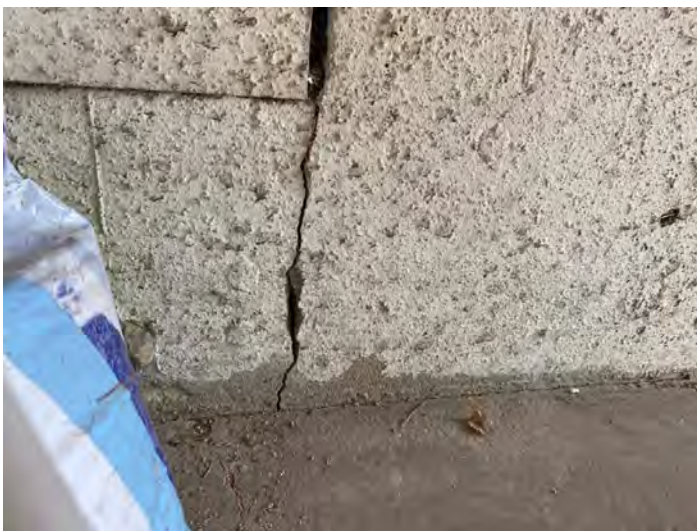
10. ☐☐☐☒☐ Driveway **Concrete** Comments **Cracks and settlement noted on drive.**  
11. ☐☐☐☒☐ Structure condition Comments **Crack(s) noted on foundation at South wall. Recommend repair as needed.**

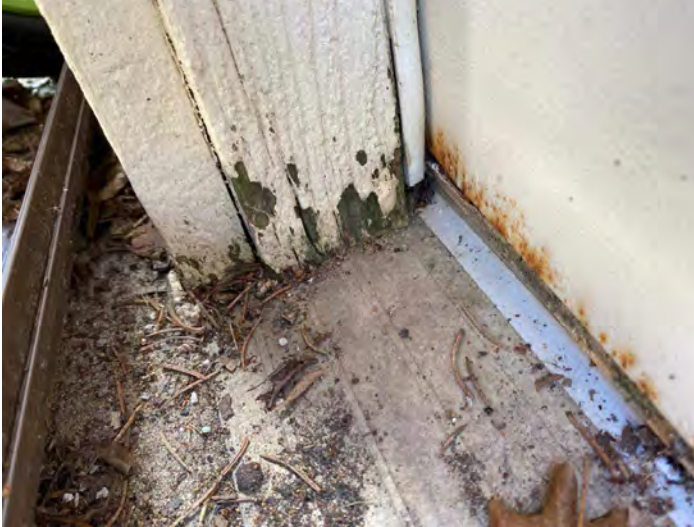
14. ☐☐☐☒ Service doors to exterior Comments Rot noted on service door trim and jamb. Loose weather stripping noted. Recommend repair or replacement as needed. Due to much stuff stored in front of service door, not able to test operation or fully inspect. Make sure operational prior to closing.

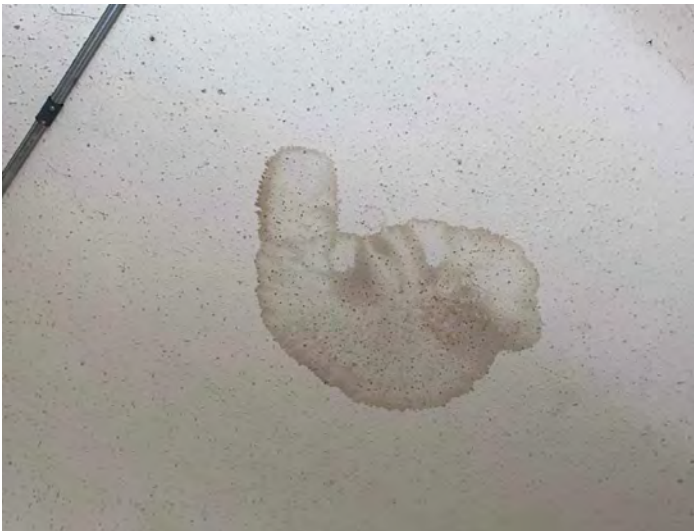
16. ☐☐☐☒ Finished Walls and Ceiling: Comments Stains noted on ceiling. No active visible leaks noted at this time. Recommend asking seller about history of stains and if repairs performed. Proceed as needed.

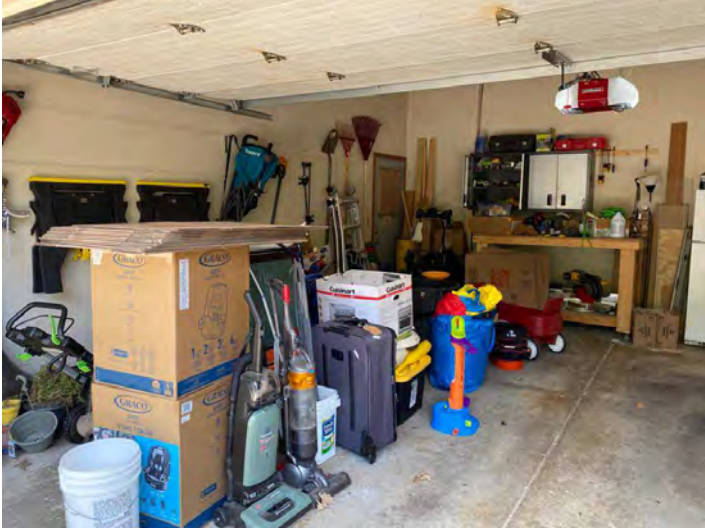
22. Additional Comments Due to much stored in garage, not all visible or accessible to inspect.

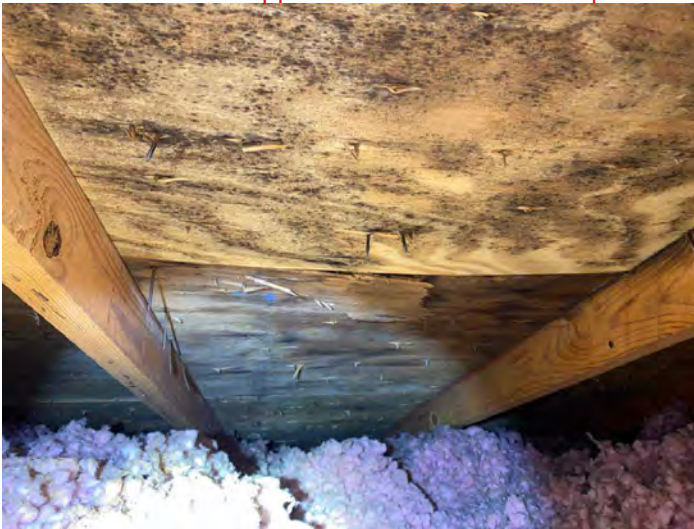
7. ☐ ☐ ☐ ☒ ☐ Roof Sheathing Comments Suspect mold like substance noted on sheathing boards at upper attic. Recommend having checked and evaluated for removal prior to closing. Damaged sheathing board noted in SE side of upper attic. Recommend repair as needed.

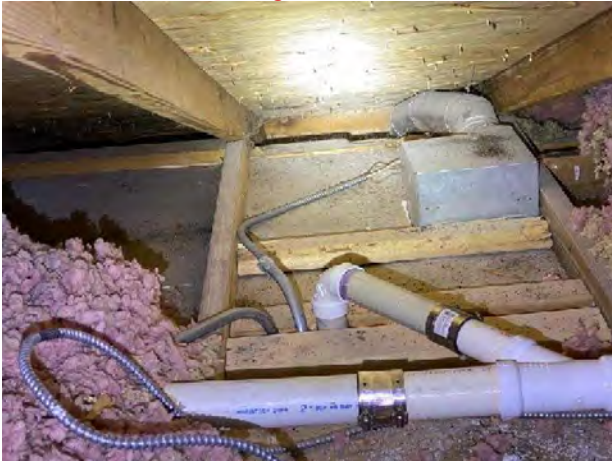
8. ☐ ☐ ☐ ☒ ☐ Insulation 8-10 Blown Fiberglass Comments Missing insulation noted at master bath area. Recommend installing.

18. Upper hallway Attic Insulation 8-10 Blown Fiberglass Missing insulation noted at master bath area. Recommend installing.

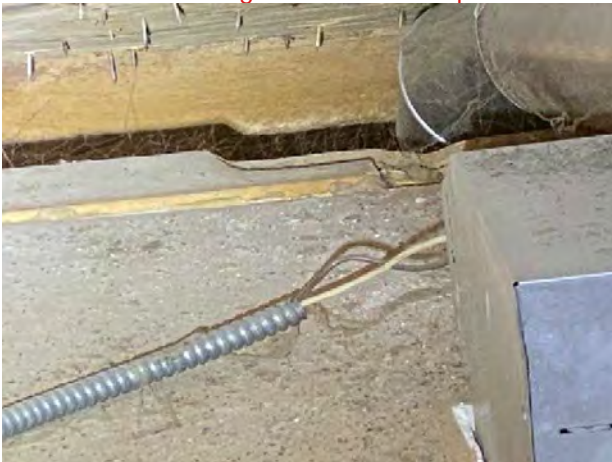
9. ☐ ☐ ☐ ☒ ☐ Bathroom/Kitchen Exhaust Vents Comments Exposed and or spliced wiring noted at bath fan. Recommend having checked and repaired.

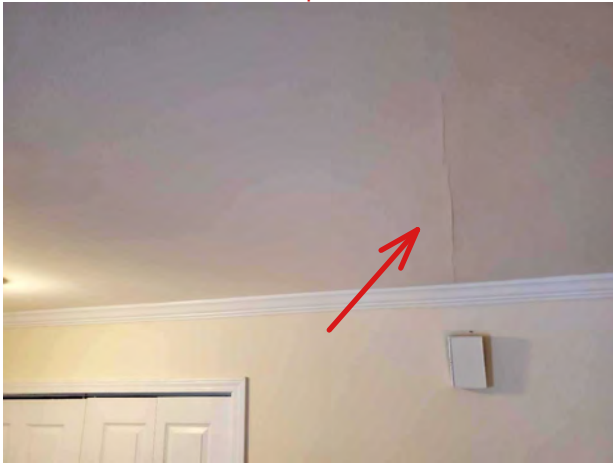
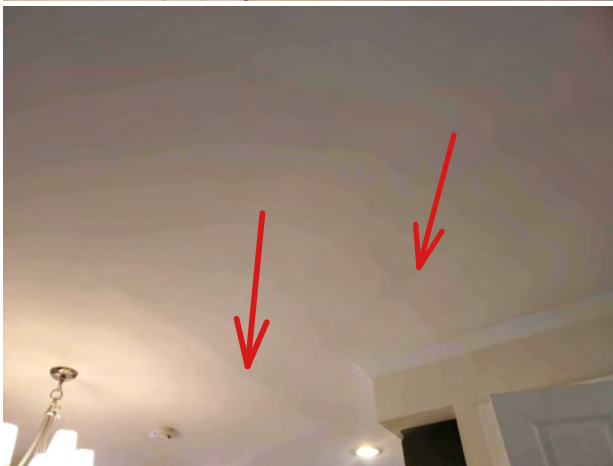
1. ☐☐☐☒ Interior Stairs/Handrails Comments FYI handrails are recommended to run into walls. FYI: All handrails should return back to walls at ends. Potential safety.
2. ☐☐☐☒ Doors Comments Door is rubbing or sticking on jamb at NE bedroom. Recommend repair for proper function.
3. ☐☐☐☒ Windows Comments Crank hardware is stripped or missing at living room left bay window. Recommend repair or replace as needed.
4. ☒☐☐☐ Walls
5. ☐☐☐☒ Ceilings Comments Crack(s) noted on ceiling at front entry way. Cracked or loose tape joints noted at kitchen. Recommend repairs as needed.

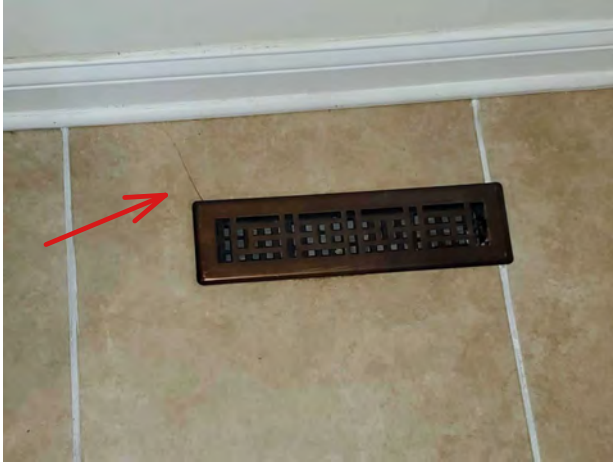
6. ☐☐☐☒☐ Floors Comments Squeaks noted on stairs and master bedroom. Cracked or loose tiles noted at front entryway. Recommend repairs as needed. FYI: This inspection does not cover any damage concealed by carpeting, rugs or furniture.

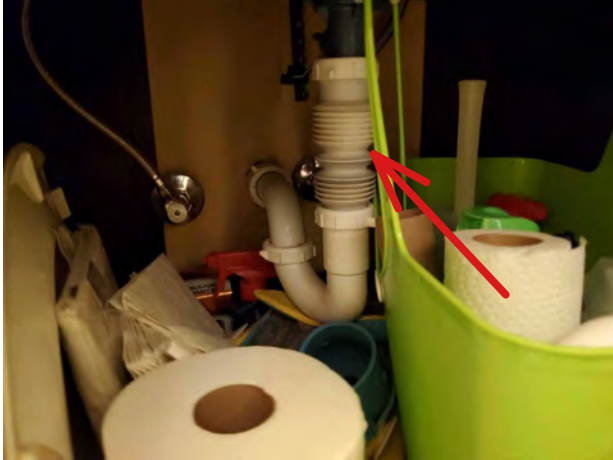
1. ☐☐☐☒☐ Sink/Basin Comments Flex drain(s) used. Recommend replacing with rigid plastic pipe as needed.

27. 2nd floor hall bath Bathroom Sink/Basin Flex drain(s) used. Recommend replacing with rigid plastic pipe as needed.

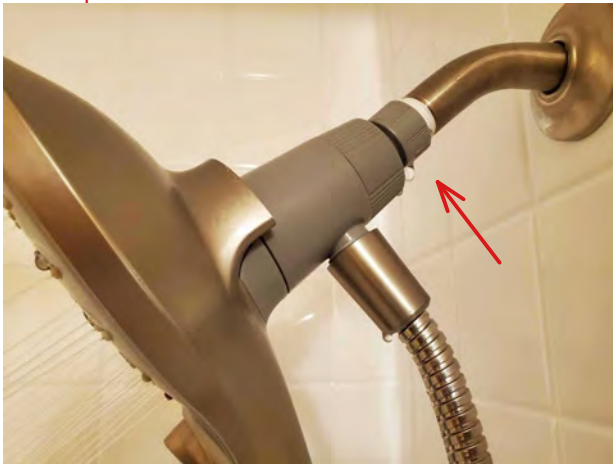
5. ☐☐☐☒☐ Tub/Whirlpool Tub/Shower Comments Leak noted at shower head connection. Shower diverter is not sealing completely (still get water out of faucet when shower running). Recommend having checked and repaired as needed.

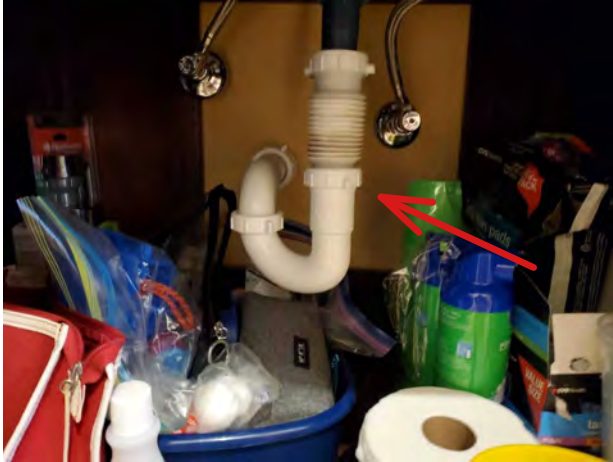
15. ☐☐☐☒☐ Sink/Basin Comments Flex drain(s) used. Recommend replacing with rigid plastic pipe as needed. Picture is sample.

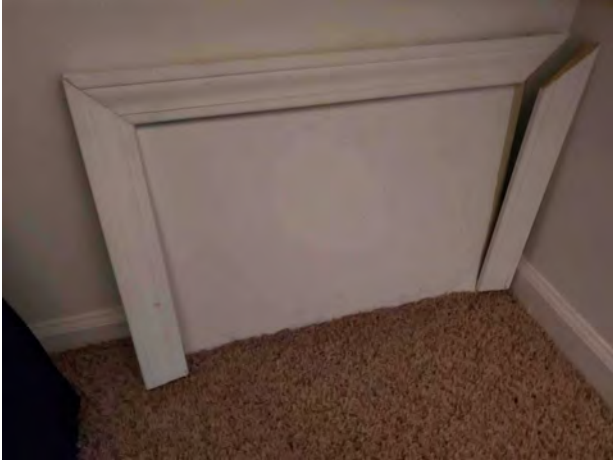
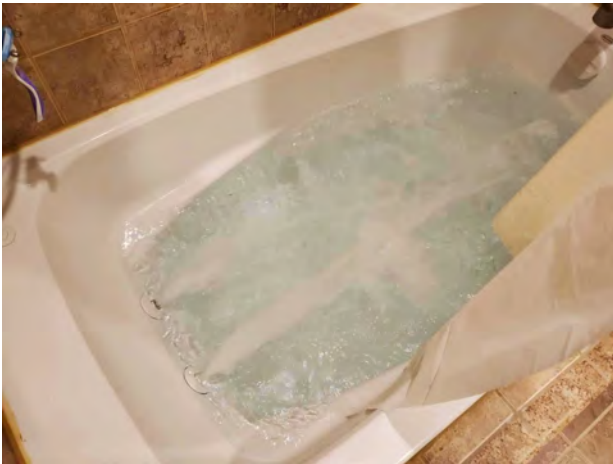
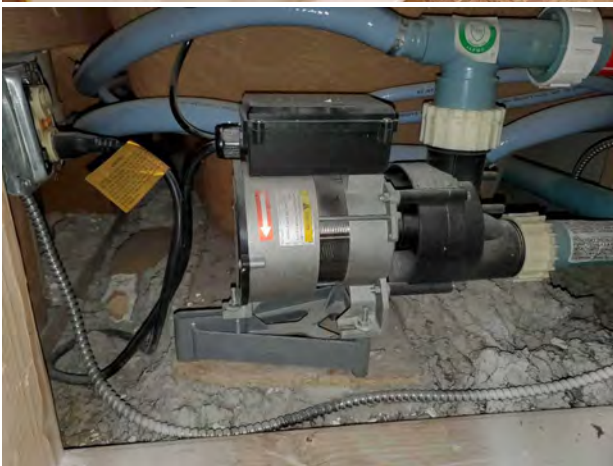
Tub/Whirlpool (continued)

19. ☐☐☐☒☐ Tub/Whirlpool Tub/Shower/Whirlpool Comments Leak noted at shower sprayer hose when shower head is active. Recommend repair or replace as needed. FYI cover panel to whirlpool access is broken. Whirlpool pump was operational at this time and no active visible leaks noted. FYI: not all jet plumbing is visible from access.

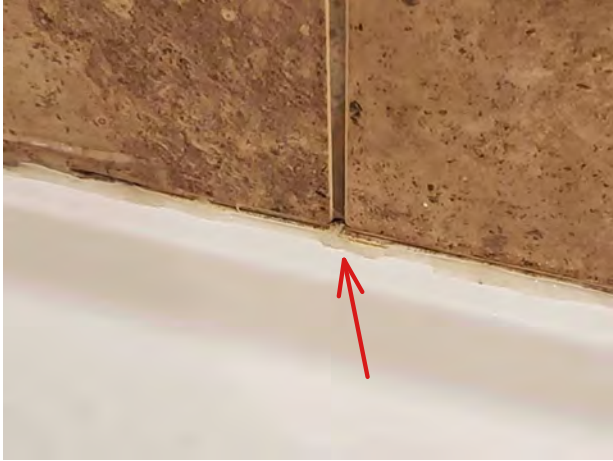
21. ☐☐☐☒☐ Surround Tile Comments Caulking has failed at shower surround. Recommend replacing with new caulk as needed.

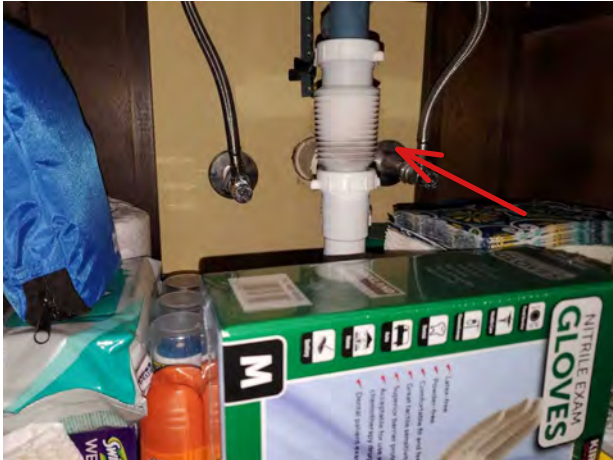
29. ☐☐☐☒☐ Sink/Basin Comments Flex drain(s) used. Recommend replacing with rigid plastic pipe as needed.

33. 1st floor 1/2 bath Bathroom Sink/Basin Flex drain(s) used. Recommend replacing with rigid plastic pipe as needed.

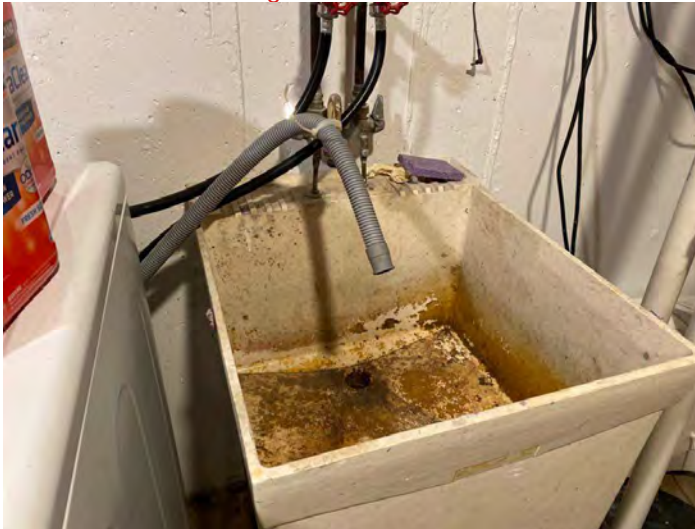
1. ☒ ☐ ☐ ☐ ☐ Electrical/Outlets/Lighting
2. ☐ ☐ ☐ ☒ ☐ Laundry Sink/Basin Comments Sink sink is loose and not secured.
3. ☒ ☐ ☐ ☐ ☐ Washer Comments Washer was working at this time. (washer filled up and drained with no active visible leaks noted) Make sure still operational at final walk through. Proceed as needed.
4. ☒ ☐ ☐ ☐ ☐ Washer Shutoffs/Hoses
5. ☒ ☐ ☐ ☐ ☐ Washer Drain Comments Recommend installing lint screen on washer drain hose at sink. Also recommend attaching hose to side of sink and not tie it to faucet. Proceed as needed.

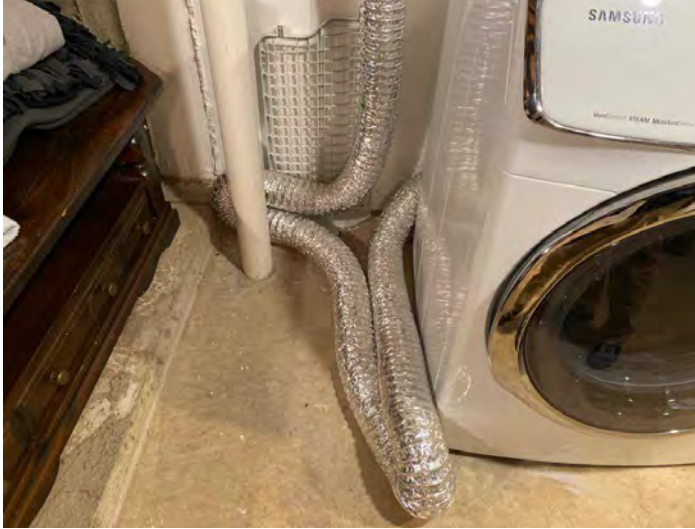
Dryer Vent (continued)

6. ☒ ☐ ☐ ☐ ☐ Dryer Comments Dryer was working at this time. (dryer heated up) Make sure still operational at final walk through. Proceed as needed.
7. ☒ ☐ ☐ ☐ ☐ Gas Line/220 Outlet Gas
8. ☒ ☐ ☐ ☐ ☐ Dryer Vent Comments Recommend shortening vent hose to prevent condensation and lint getting trapped in excess vent laying on ground.

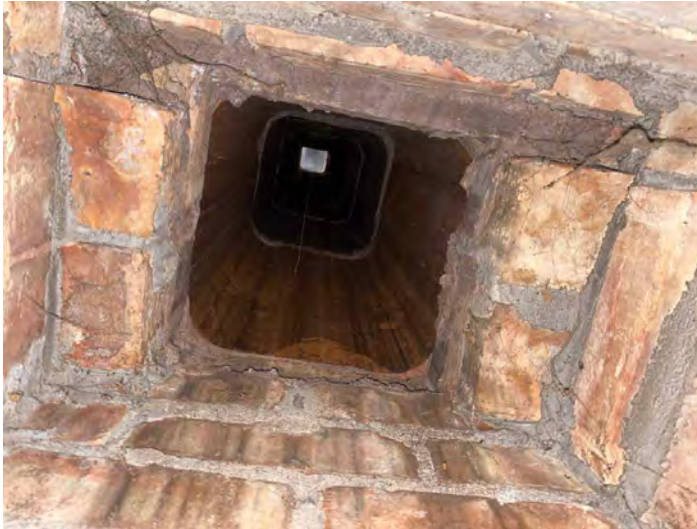
2. ☒ ☐ ☐ ☐ ☐ Damper  
3. ☒ ☐ ☐ ☐ ☐ Firebox  
4. ☐ ☒ ☐ ☐ ☐ Clean out  
5. ☒ ☐ ☐ ☐ ☐ Overall Fireplace Condition Comments **Not all flue visible from inside firebox.**

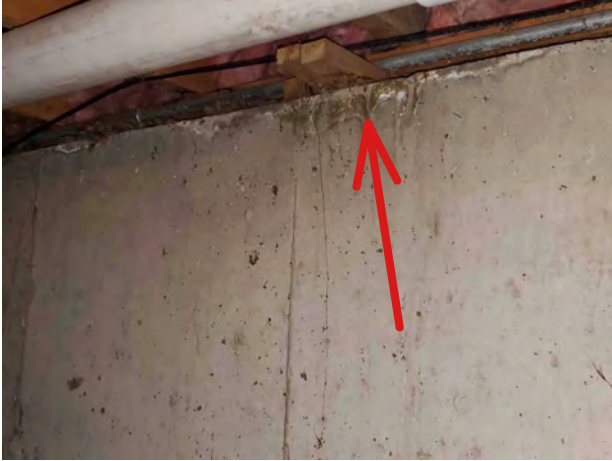
3. ☐☐☐☒☐ Water Penetration Comments Efflorescence noted on foundation at East wall in crawl. Recommend having checked and evaluated.

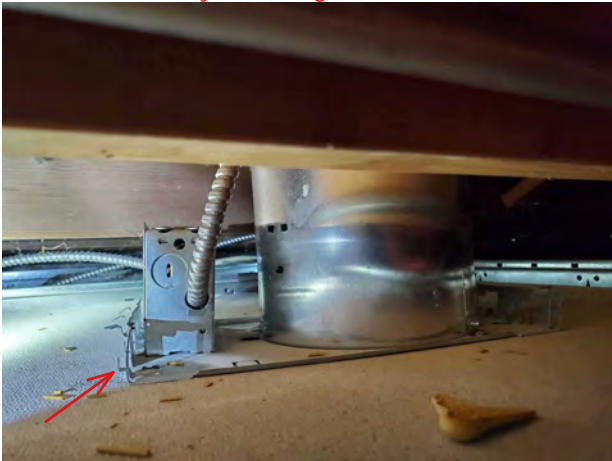
4. ☒☐☐☐☐ Floor -Concrete  
5. ☒☐☐☐☐ Piers/Posts -Steel Posts Comments Finished basement, not all visible.  
6. ☒☐☐☐☐ Joists/Trusses/Sub Floor -2x10 Comments Finished ceiling, not all visible to inspect.  
7. ☒☐☐☐☐ Beams Comments Finished ceiling, not able to view beam(s) to inspect.  
8. ☐☐☐☒☐ Stairs/Handrails Comments FYI handrails are recommended to run into walls. FYI: All handrails should return back to walls at ends. Potential safety.  
9. ☒☐☐☐☐ Finished Walls/Ceilings  
10. ☐☐☐☒☐ Windows/Doors/Vents Comments Rust noted on metal window frames. Recommend sanding and painting to prevent future rust. South door to laundry rubs on jamb. Recommend repair as needed.  
11. ☐☐☐☒☐ Electrical Comments No three way switch installed for stairway light. Can lights do not have support brackets to carry the weight to the frame.

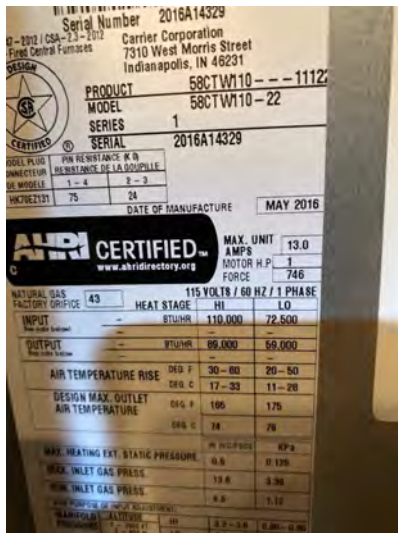
1. Type of System- **Gas forced air**
2. Manufacturer- **Carrier**
- 3.

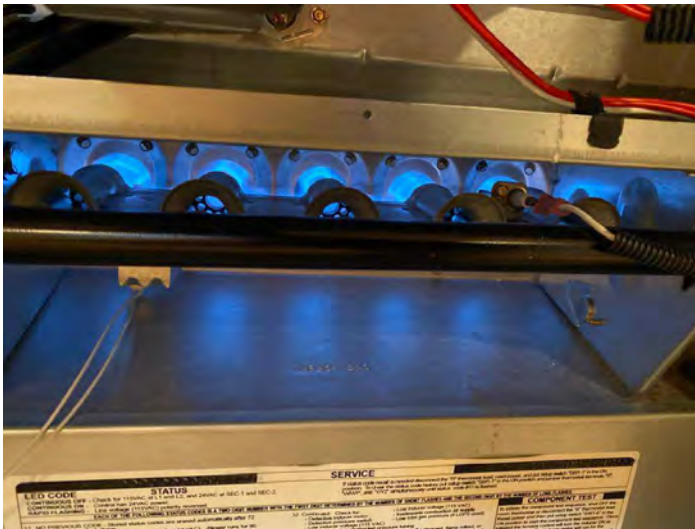
6. ☒ ☐ ☐ ☐ ☐ Blower
7. ☒ ☐ ☐ ☐ ☐ Combustion Chamber Comments **Not much of chamber visible due to design. Rating is for the 10% that is visible and not the 90% that is not.**

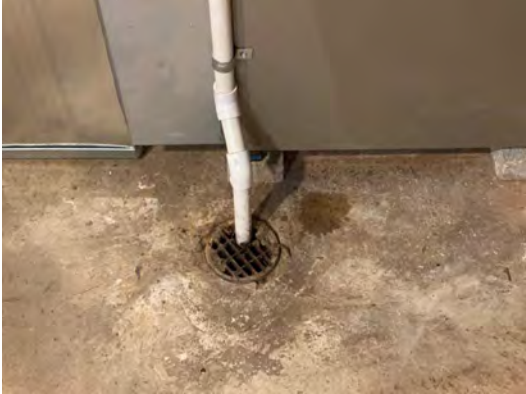
11. ☒ ☐ ☐ ☐ ☐ Ducts/Distribution  
12. ☒ ☐ ☐ ☐ ☐ Adequate Combustion Air  
13. ☒ ☐ ☐ ☐ ☐ Gas Line/Shutoffs  
14. ☐ ☐ ☐ ☒ ☐ Humidifier Comments **Dripping from cover, pad dirty. Recommend changing.**

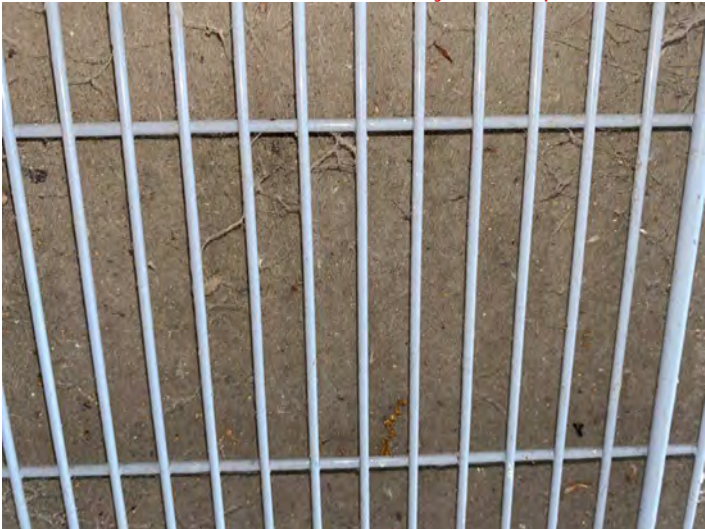
1. Manufacturer- Carrier
2. Voltage- 208-230 VAC
3. Amperage- 40 Amps Size/Tons- 3.5 Ton
4. Estimated Age- 4 yrs Life Expectancy- 15 yrs  
S NPNI F P
5. ☒ ☐ ☐ ☐ ☐ Operation Comments Unit is cooling at this time. Noted 19 degree temperature differential taken at supply and return registers. Make sure unit is still cooling at final walk through. Proceed as needed.
6. Disconnect at unit ☒ Yes ☐ No
7. Operated ☒ Yes ☐ No
8. Additional Comments Fins are dirty at compressor outside. Recommend cleaning for proper function.

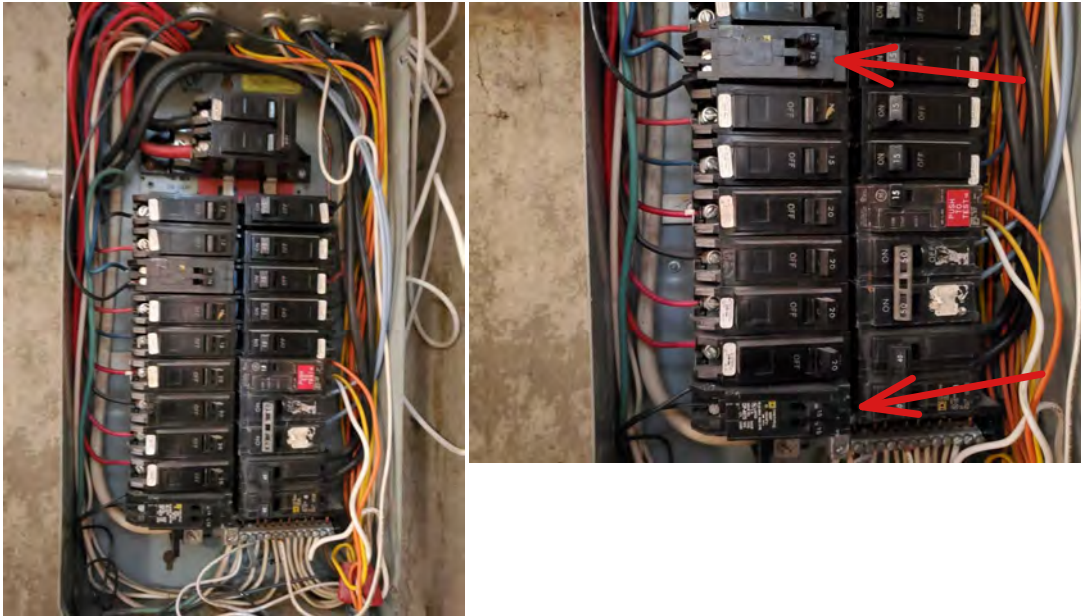
1. Service to house- **Underground Service**
2. Phase- **1 Phase**
3. Volts- **110/240 Volts**
4. Size of Service Wires- **2 Aluminum**
5. Panel Rating- **100 Amps**  
S N P N I F P
6. ☐☐☐☒ Main Panel Comments **Slim line breakers present, panel is not rated for extra circuits. Recommend electrician check and advise. Proceed as needed.**

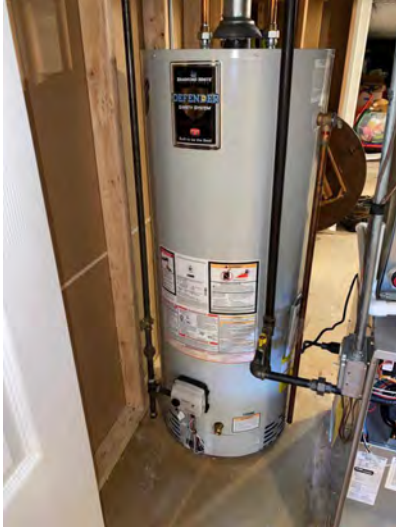
20. ☒ ☐ ☐ ☐ ☐ Water Heater Operation: Comments Water heater was operational and no active visible leaks noted at this time.

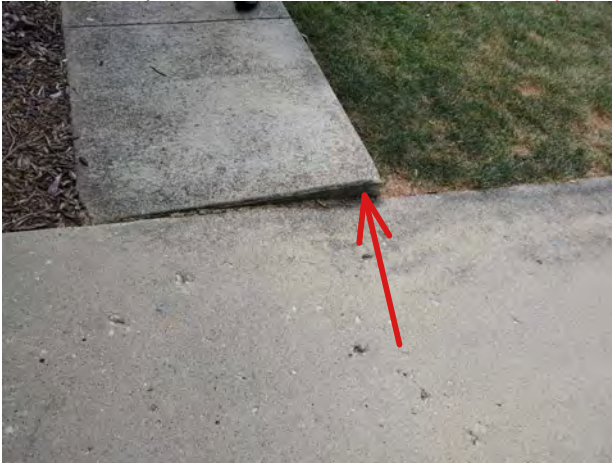
1. Trees, Shrubs, Vegetation. Etc. **Tree limbs over hang the roof and should be cut back.**
2. Steps, Stoops, Walks **Walk is uneven and a potential trip hazard at front sideways. Recommend repair as needed.**

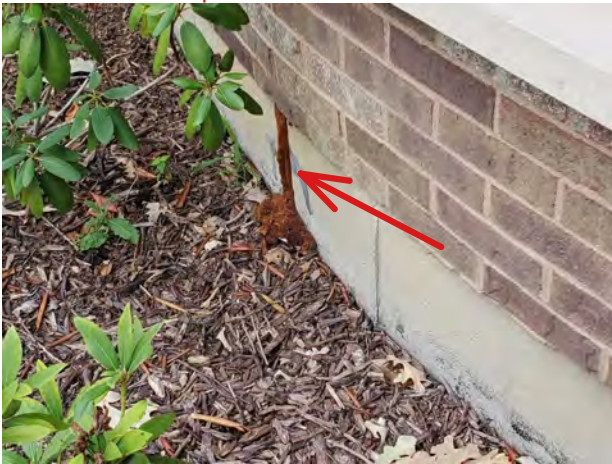
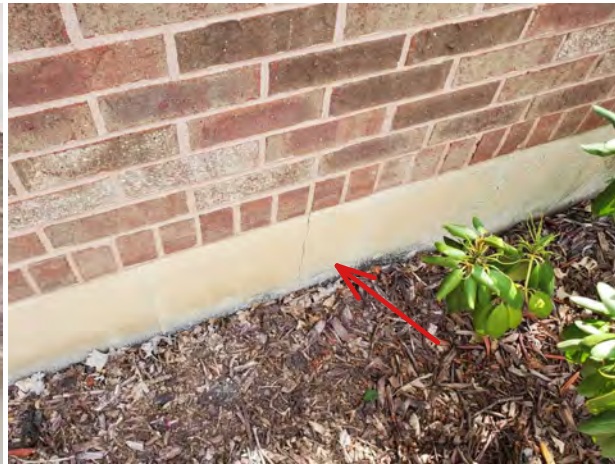
3. Foundation **-Poured Concrete Cracks noted on foundation at SW wing wall. Crack repair noted at West side. Recommend repairs as needed.**

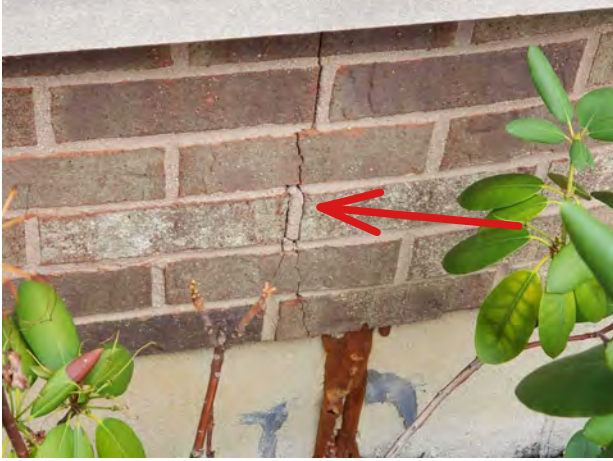
4. Siding **Brick and aluminum Cracked, missing or loose mortar noted on bricks at West side. Dents noted on aluminum siding at NE corner near deck. Loose siding noted at upper East bedroom windows. Recommend repairs as needed.**

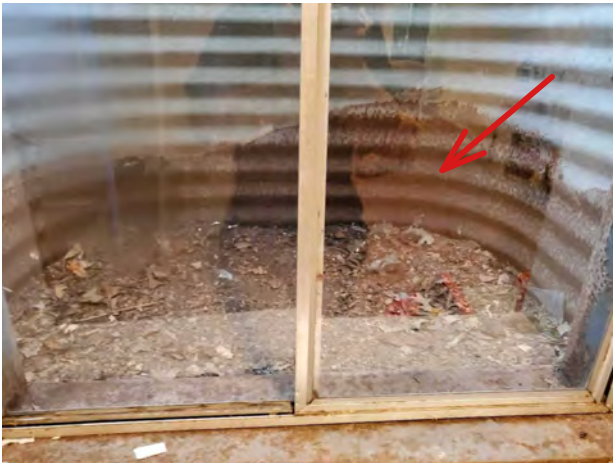
5. Window wells **Damaged cover noted at East side. Metal window frame is rusted. Recommend repair as needed and ladder needed at escape window.**

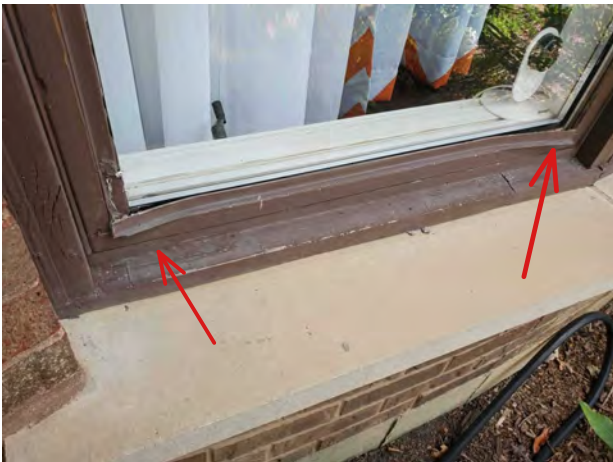
6. Storm/Entry doors **Front entry door is not latching. Repair needed for proper function.**  
7. Windows/Screens/Storms **Plastic glaze pieces around front bay window is damaged. Recommend repair as needed.**

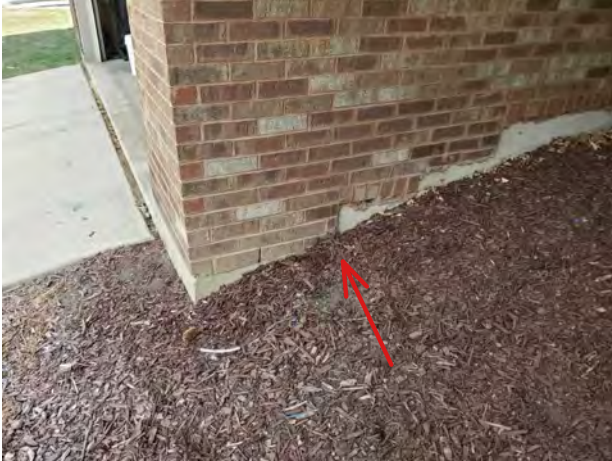
9. Dirt touching wood Dirt or mulch is covering bricks at West side. Dirt or mulch is covering siding at North side, Recommend removing dirt to prevent rot or bug damage.

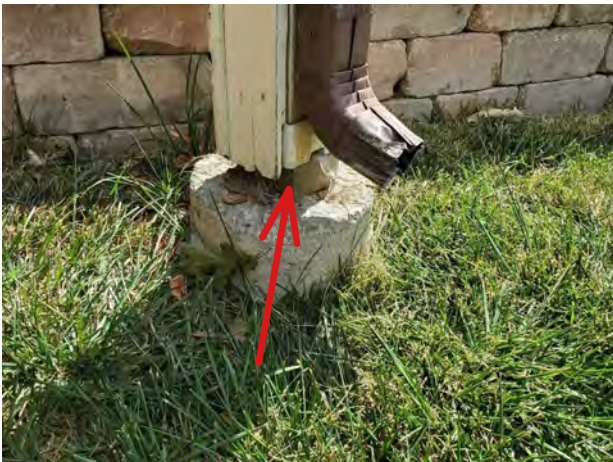
10. Porch/Gazebo Front porch post has rot and is shimmed with 2x4. Recommend having checked and repaired as needed.

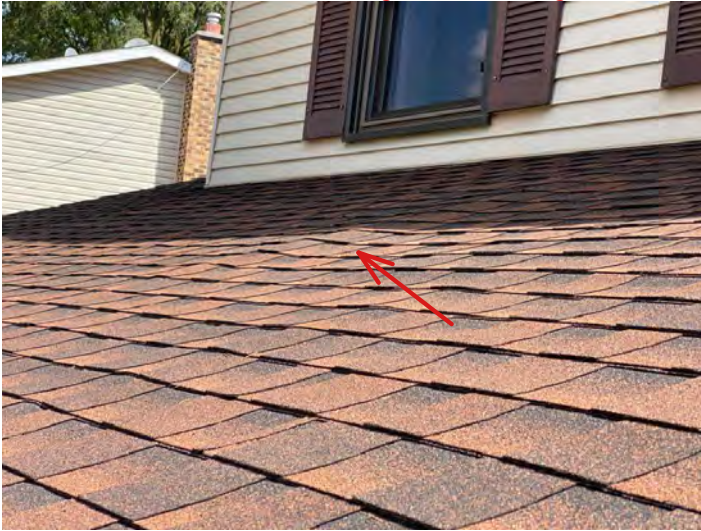
11. Deflection noted Buckled shingles/sheathing noted on lower garage roof. Recommend repair as needed.

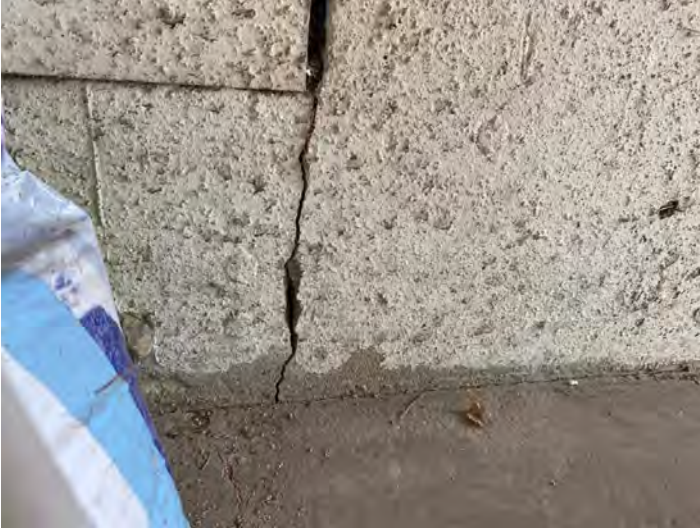
Garage Structure condition Crack(s) noted on foundation at South wall. Recommend repair as needed.

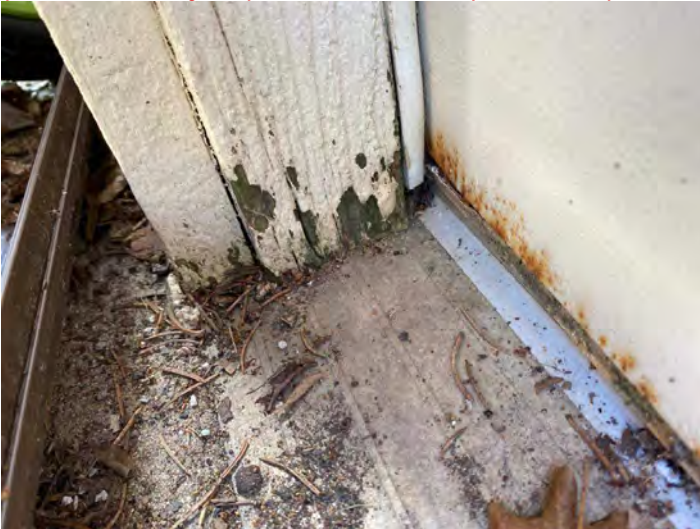
Garage Service doors to exterior Rot noted on service door trim and jamb. Loose weather stripping noted. Recommend repair or replacement as needed. Due to much stuff stored in front of service door, not able to test operation or fully inspect. Make sure operational prior to closing.

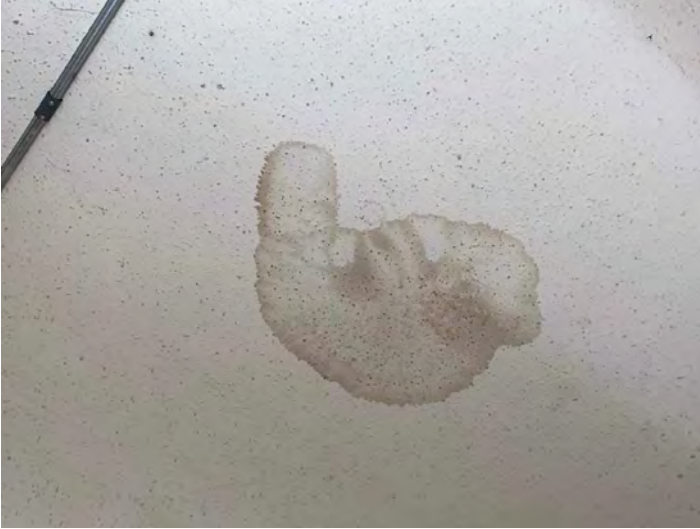
Garage Finished Walls and Ceiling: Stains noted on ceiling. No active visible leaks noted at this time. Recommend asking seller about history of stains and if repairs performed. Proceed as needed.

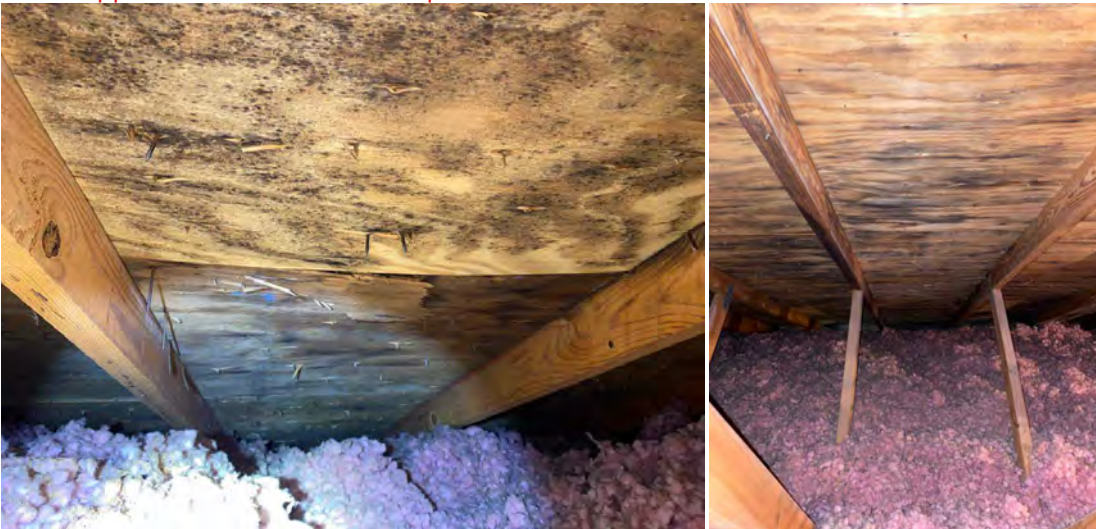
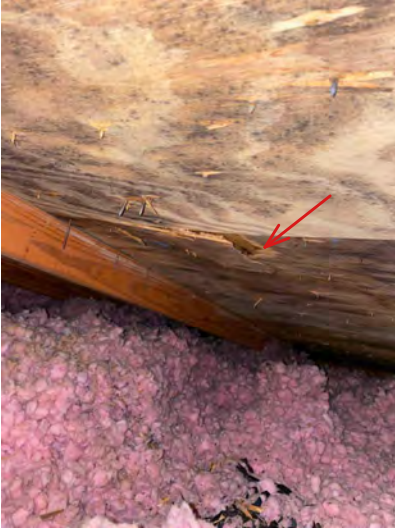
### Roof Sheathing (continued)

17. Upper hallway Attic Roof Sheathing Suspect mold like substance noted on sheathing boards at upper attic. Recommend having checked and evaluated for removal prior to closing. Damaged sheathing board noted in SE side of upper attic. Recommend repair as needed.

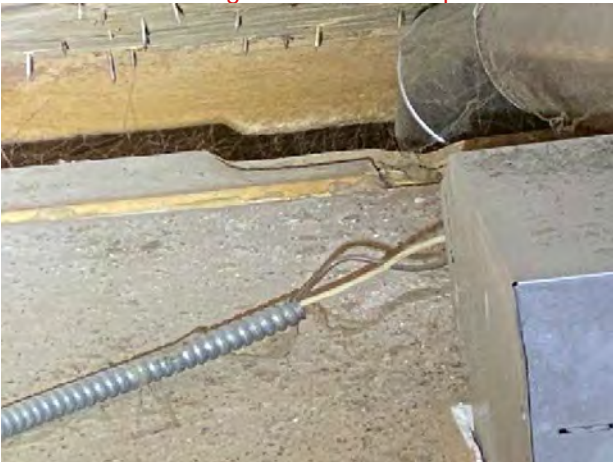
19. Upper hallway Attic Bathroom/Kitchen Exhaust Vents Exposed and or spliced wiring noted at bath fan. Recommend having checked and repaired.
