# Home Inspection Report

Inspected by:  
Dan Holzer  
Castle Home Inspections, Inc.

Style of building **2 Story**  
Approx. Age **42 yrs**  
Radon Fee: **N/A**

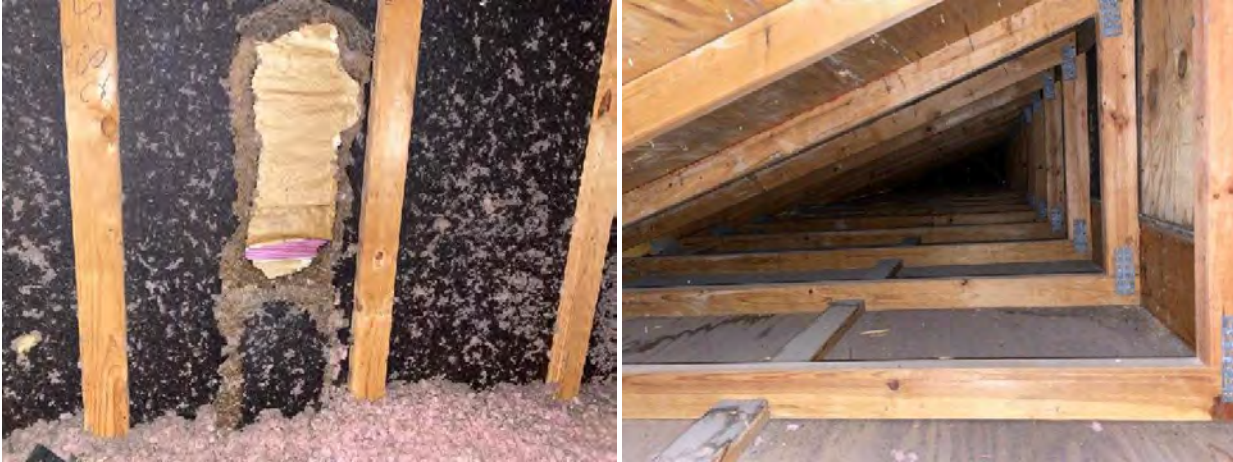
20. Upper hallway Attic Additional Comments **Damaged wall sheathing noted at both attic areas on gable walls (exposed siding noted). Recommend repair as needed. Due to limited space or volume ceilings, not all visible or accessible to inspect.**

12. Additional Comments Damaged wall sheathing noted at both attic areas on gable walls (exposed siding noted). Recommend repair as needed. Due to limited space or volume ceilings, not all visible or accessible to inspect.

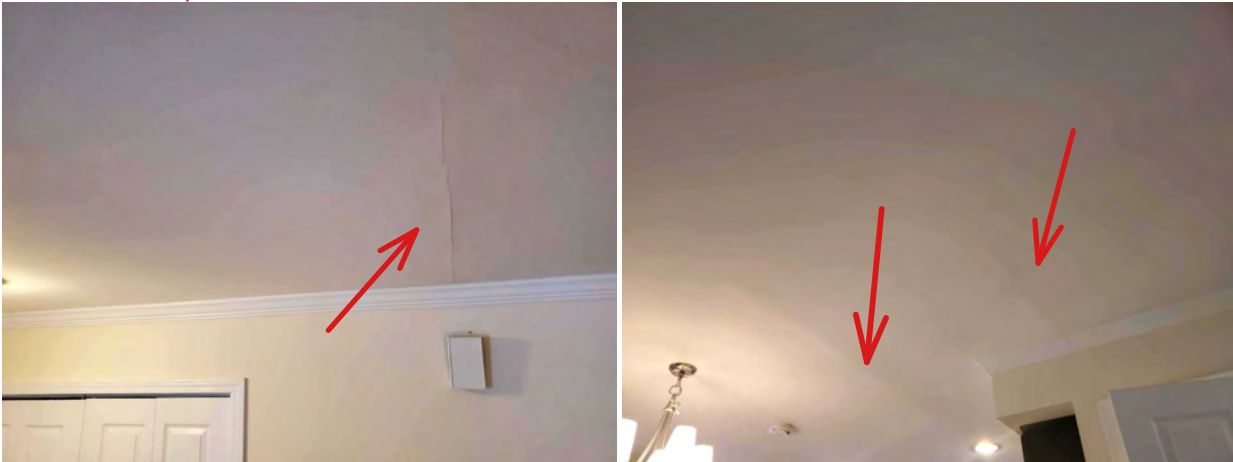
21. Interior Interior Stairs/Handrails **FYI handrails are recommended to run into walls.**  
22. Interior Doors **Door is rubbing or sticking on jamb at NE bedroom. Recommend repair for proper function.**  
23. Interior Windows **Crank hardware is stripped or missing at living room left bay window. Recommend repair or replace as needed.**  
24. Interior Ceilings **Crack(s) noted on ceiling at front entry way. Cracked or loose tape joints noted at kitchen. Recommend repairs as needed.**

1. ☐☐☐☒ Interior Stairs/Handrails Comments FYI handrails are recommended to run into walls. FYI: All handrails should return back to walls at ends. Potential safety.
2. ☐☐☐☒ Doors Comments Door is rubbing or sticking on jamb at NE bedroom. Recommend repair for proper function.
3. ☐☐☐☒ Windows Comments Crank hardware is stripped or missing at living room left bay window. Recommend repair or replace as needed.
4. ☒☐☐☐ Walls
5. ☐☐☐☒ Ceilings Comments Crack(s) noted on ceiling at front entry way. Cracked or loose tape joints noted at kitchen. Recommend repairs as needed.

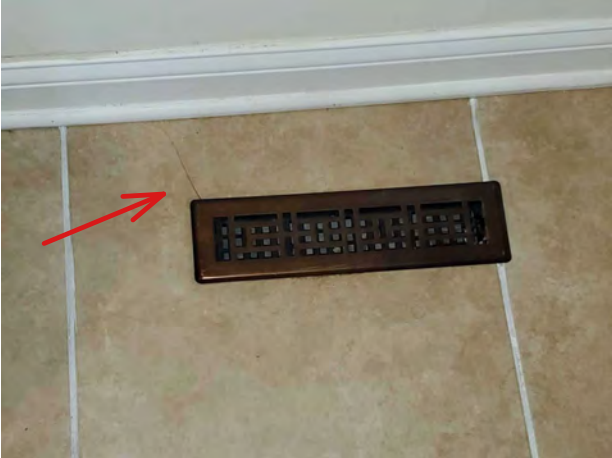
25. Interior Floors Squeaks noted on stairs and master bedroom. Cracked or loose tiles noted at front entryway. Recommend repairs as needed.

6. ☐☐☐☒☐ Floors Comments Squeaks noted on stairs and master bedroom. Cracked or loose tiles noted at front entryway. Recommend repairs as needed. FYI: This inspection does not cover any damage concealed by carpeting, rugs or furniture.

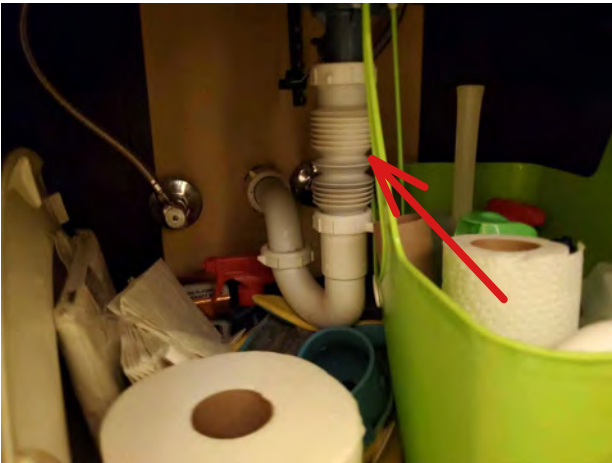
27. 2nd floor hall bath Bathroom Sink/Basin Flex drain(s) used. Recommend replacing with rigid plastic pipe as needed.

1. ☐☐☐☒☐ Sink/Basin Comments Flex drain(s) used. Recommend replacing with rigid plastic pipe as needed.

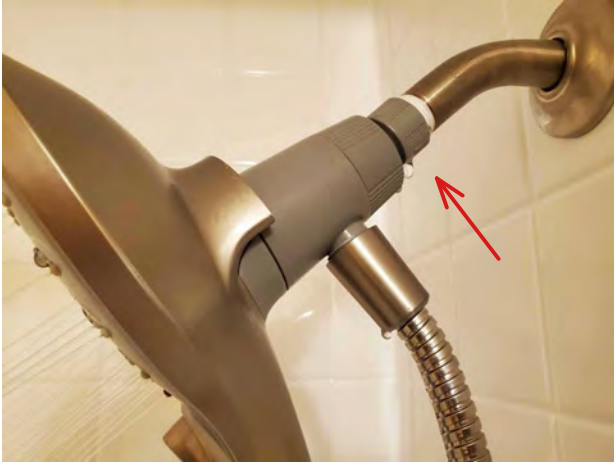
29. 2nd floor hall bath Bathroom Tub/Whirlpool Tub/Shower Leak noted at shower head connection. Shower diverter is not sealing completely (still get water out of faucet when shower running). Recommend having checked and repaired as needed.

5. ☐☐☐☒☐ Tub/Whirlpool Tub/Shower Comments Leak noted at shower head connection. Shower diverter is not sealing completely (still get water out of faucet when shower running). Recommend having checked and repaired as needed.

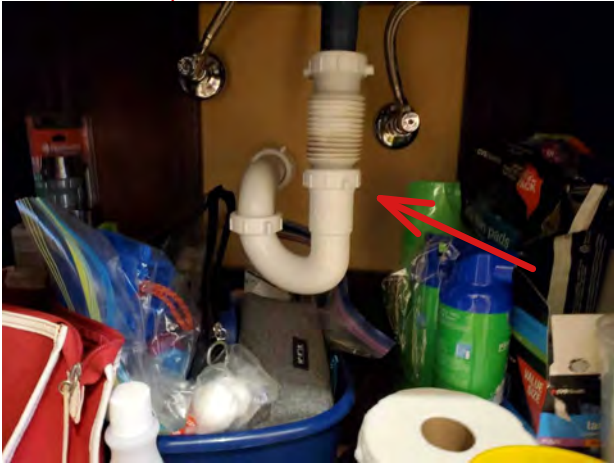
30. Master bath Bathroom Sink/Basin Flex drain(s) used. Recommend replacing with rigid plastic pipe as needed. Picture is sample.

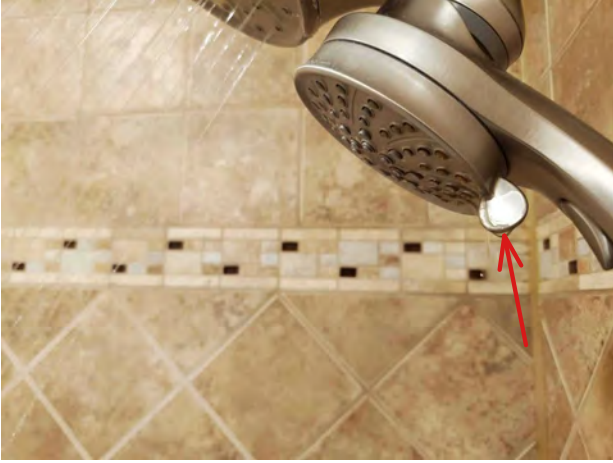
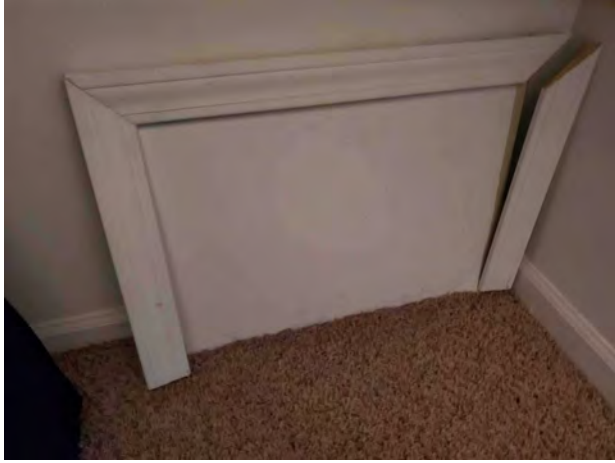
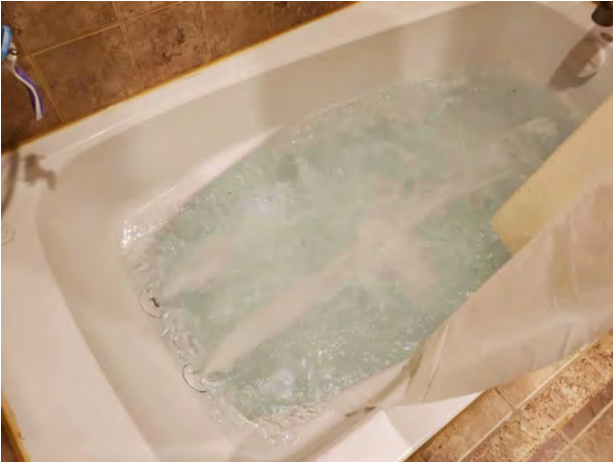
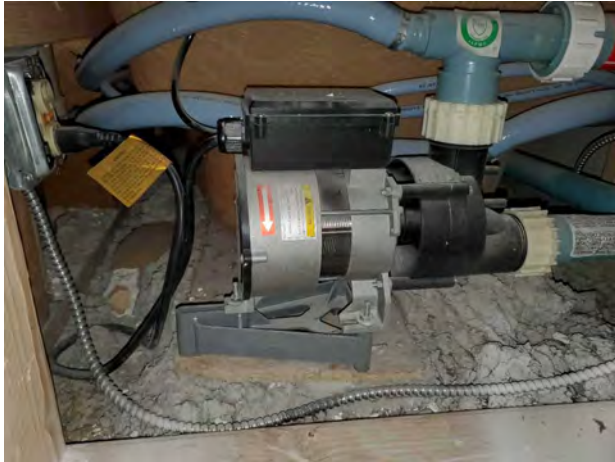
31. Master bath Bathroom Tub/Whirlpool Tub/Shower/Whirlpool Leak noted at shower sprayer hose when shower head is active. Recommend repair or replace as needed. FYI cover panel to whirlpool access is broken. Whirlpool pump was operational at this time and no active visible leaks noted. FYI: not all jet plumbing is visible from access.

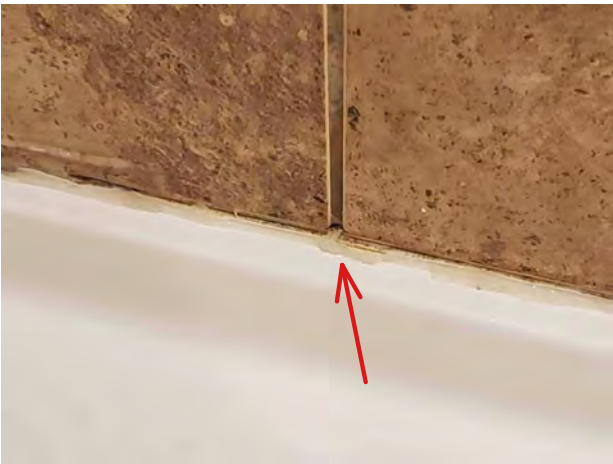
32. Master bath Bathroom Surround Tile Caulking has failed at shower surround. Recommend replacing with new caulk as needed.

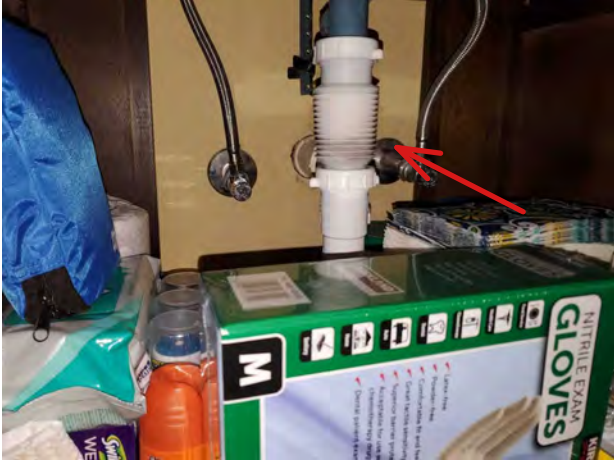
33. 1st floor 1/2 bath Bathroom Sink/Basin Flex drain(s) used. Recommend replacing with rigid plastic pipe as needed.

29. ☐☐☐☒☐ Sink/Basin Comments Flex drain(s) used. Recommend replacing with rigid plastic pipe as needed.

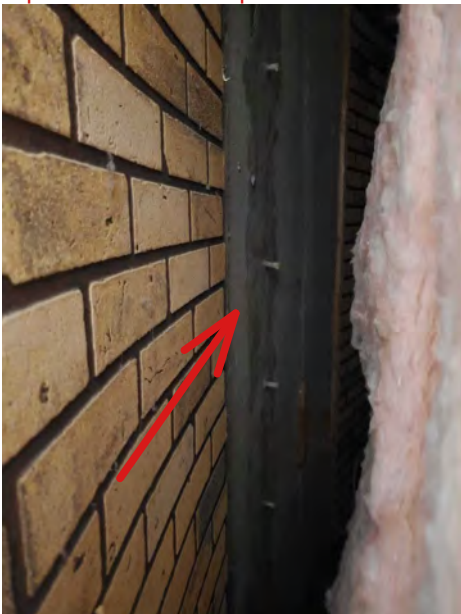
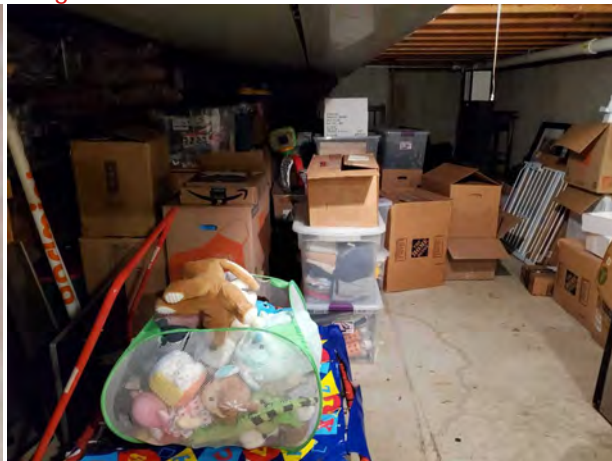
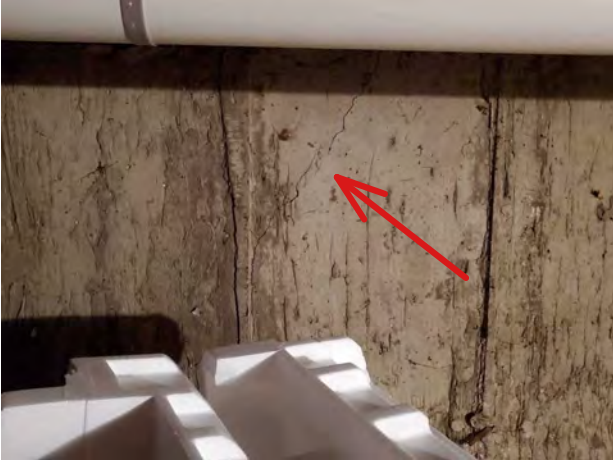
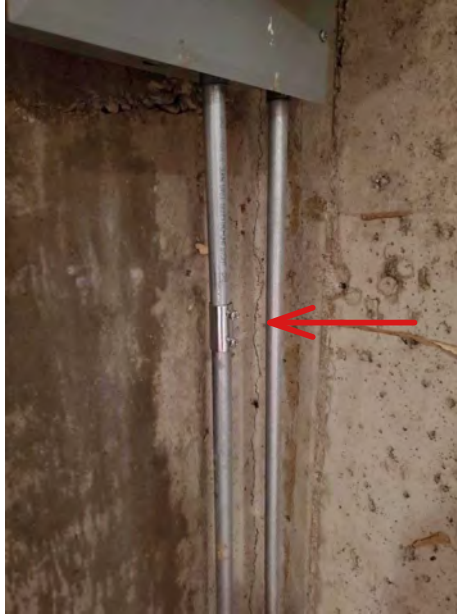
38. Foundation -Poured Concrete Crack noted at East wall in crawl and SE corner. Crack repair(s) noted at West exterior wall. Recommend asking seller if any warranties exist for work performed. Proceed as needed. Unable to inspect all of crawlspace due to stuff along walls.

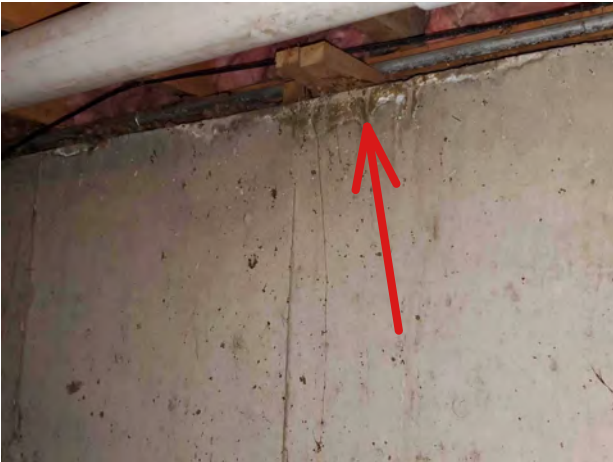
39. Water Penetration Efflorescence noted on foundation at East wall in crawl. Recommend having checked and evaluated.

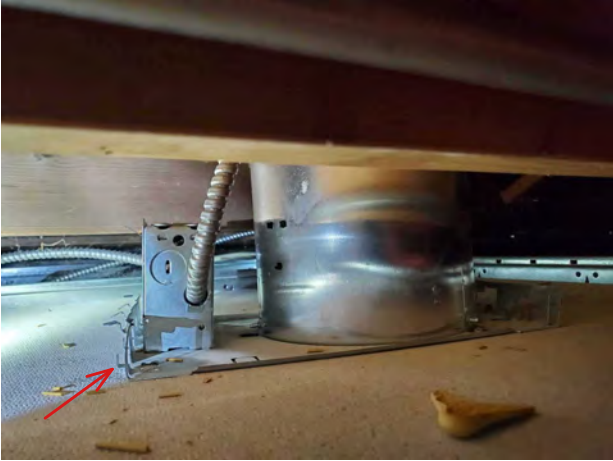
42. Electrical **No three way switch installed for stairway light. Can lights do not have support brackets to carry the weight to the frame.**

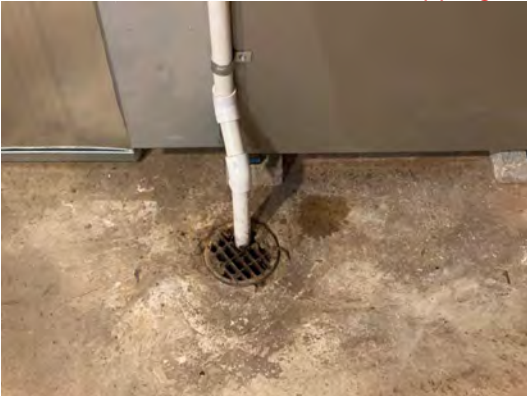
43. Basement Furnace Filters **Filter is dirty, needs replacing prior to closing.**  
44. Basement Furnace Humidifier **Dripping from cover, pad dirty. Recommend changing.**

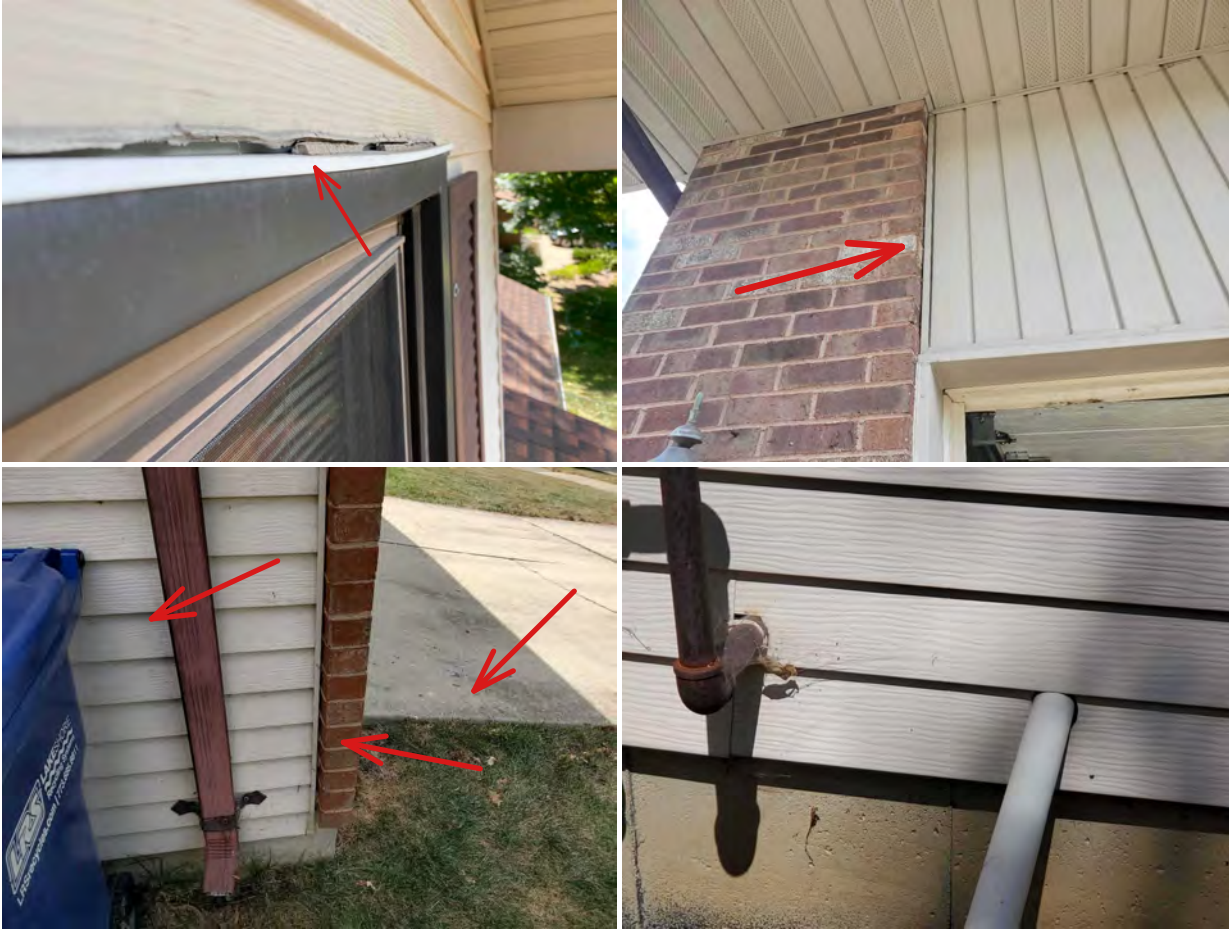
1. Caulking Missing caulking noted at siding to brick transitions and wall penetrations at South side. Failed caulking noted at window and door openings, recommend replacing to prevent water entry.
